RYDIS H68 Pro Side Brush Motor Replacement

The motor that controls the side brush may be defective causing the side brush to stop spinning in your RYDIS H68 Pro. Replacement guide here.

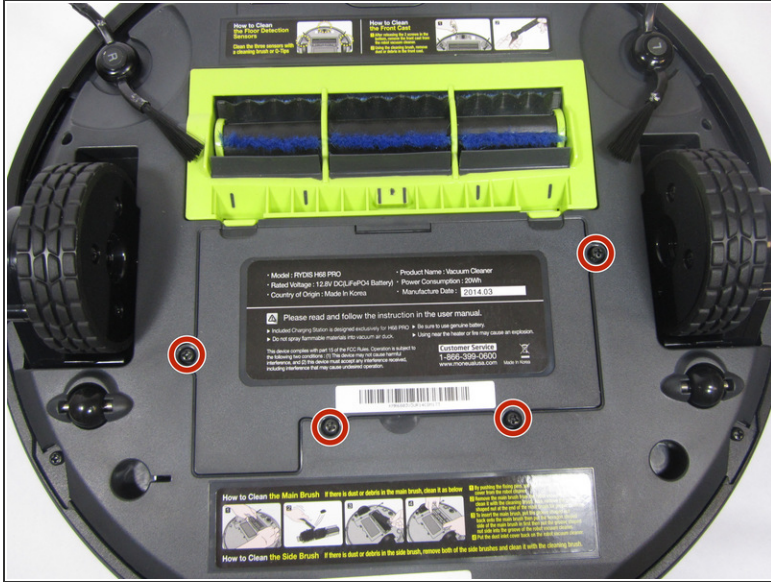
Step 1 — Battery

- Flip the vacuum over so that the wheels are facing you.
- Use a Phillips #1 screwdriver to remove the four 10mm screws that surround the battery cover.

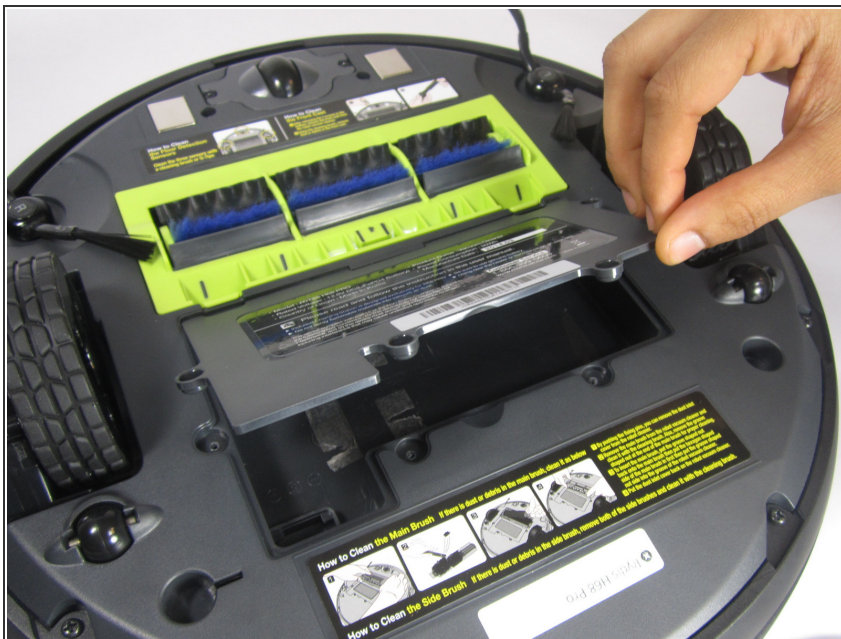
Step 2

- Lift up the battery cover to reveal the battery.
- Remove the battery.

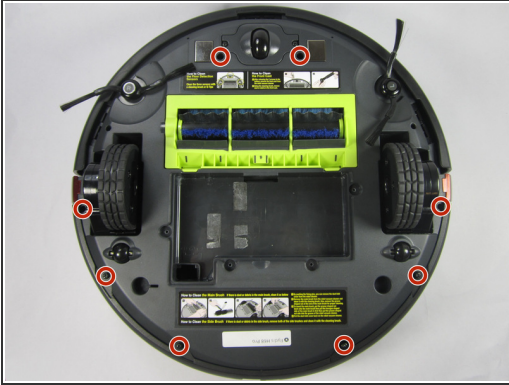
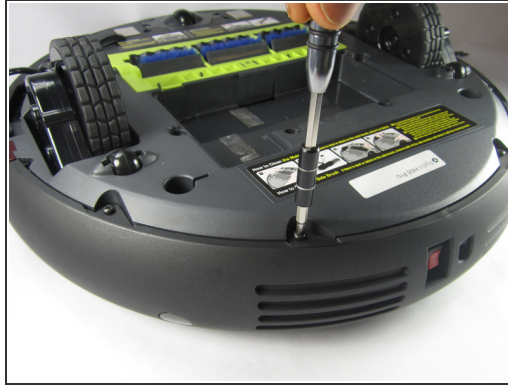
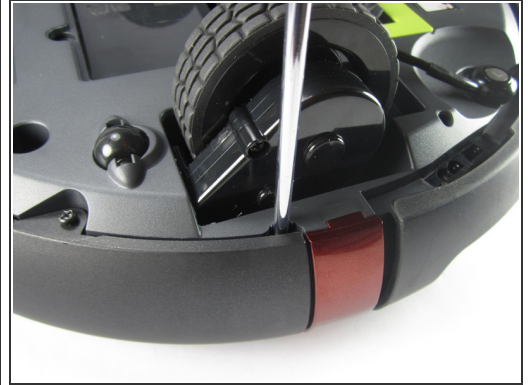
Step 3 — Bumper

- Remove the eight 10 mm Phillips #1 screws.

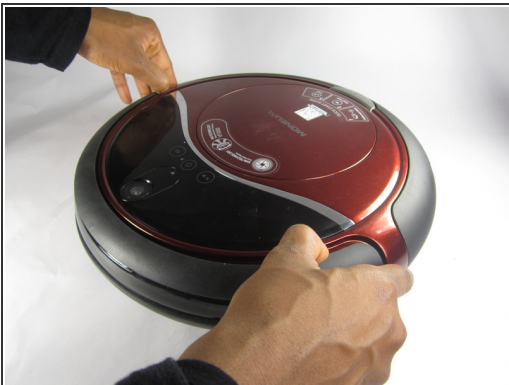
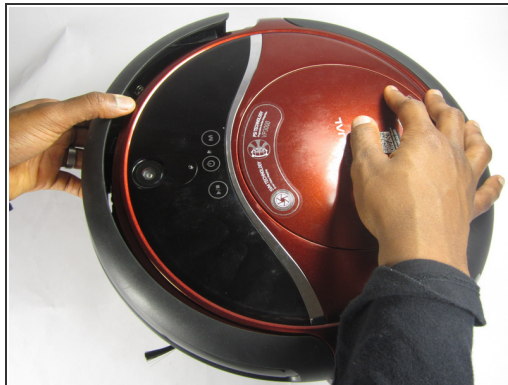
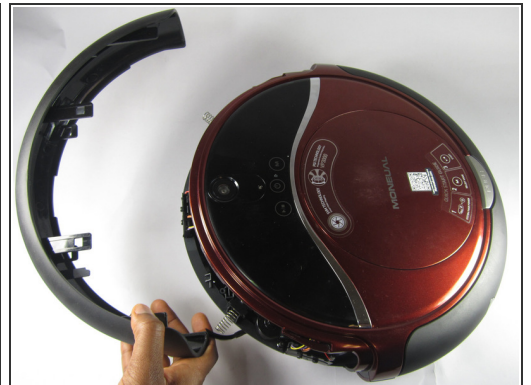
Step 4

- Hold the front bumper and pull it off.
- ⓘ It requires a lot of force to pull the bumper off.

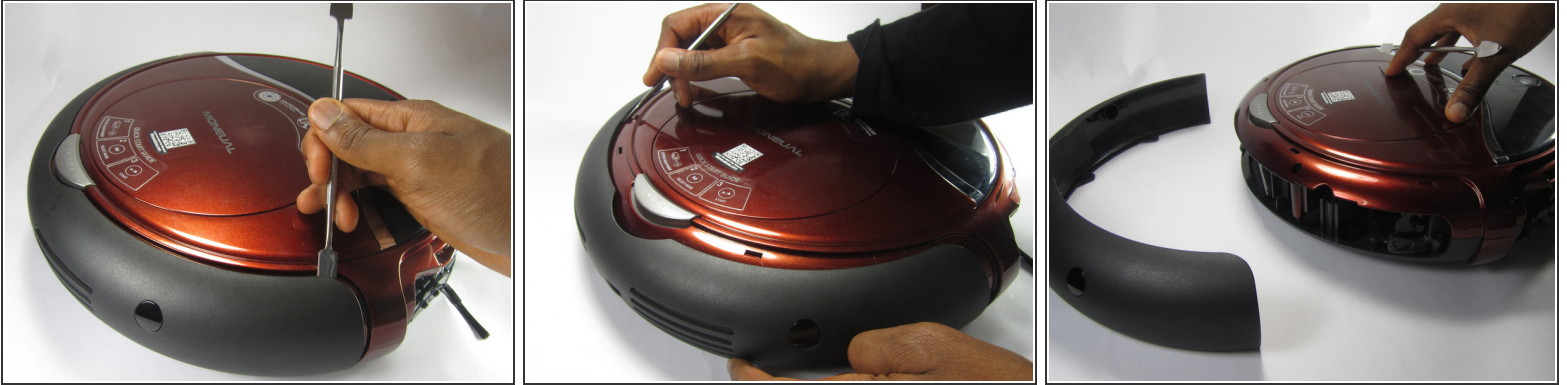
Step 5

- Pry off the back bumper by going around the entire top of the bumper with the metal spudger.
